NBS 81-2243

Corrosion Evaluation of Underground Telephone Cable Shielding Materials

Progress Report
1976-1980

Rural Electrification Administration

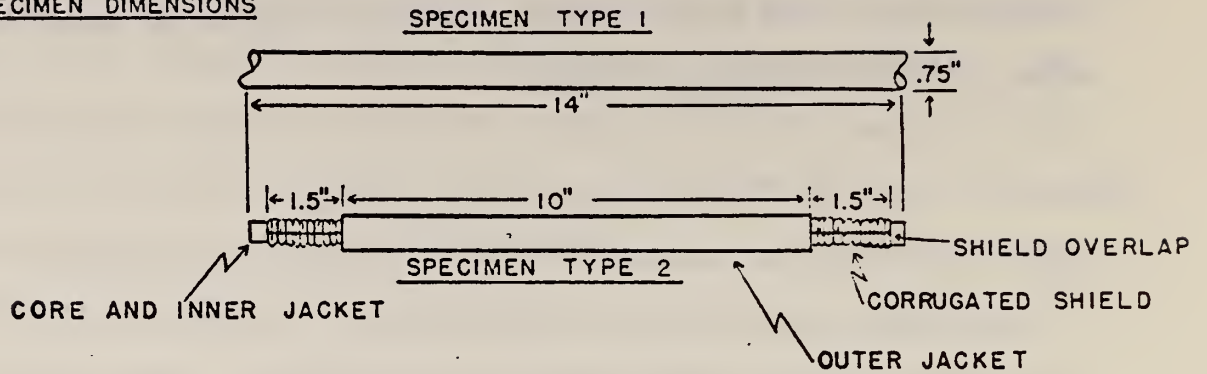
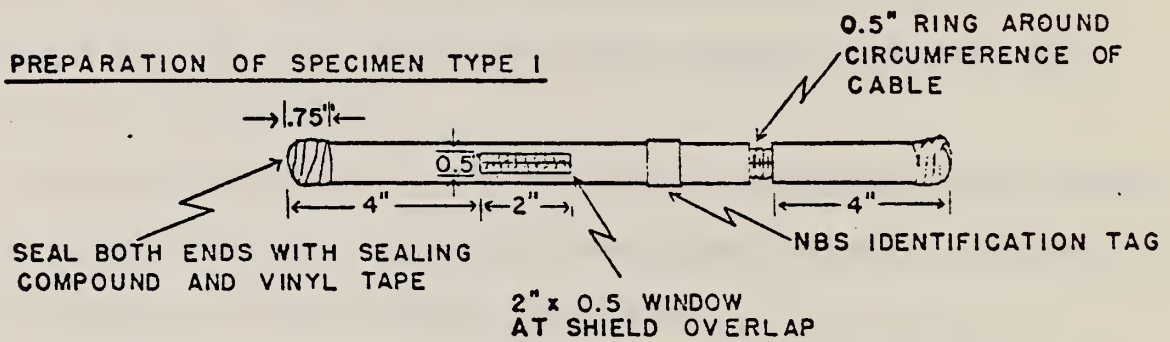
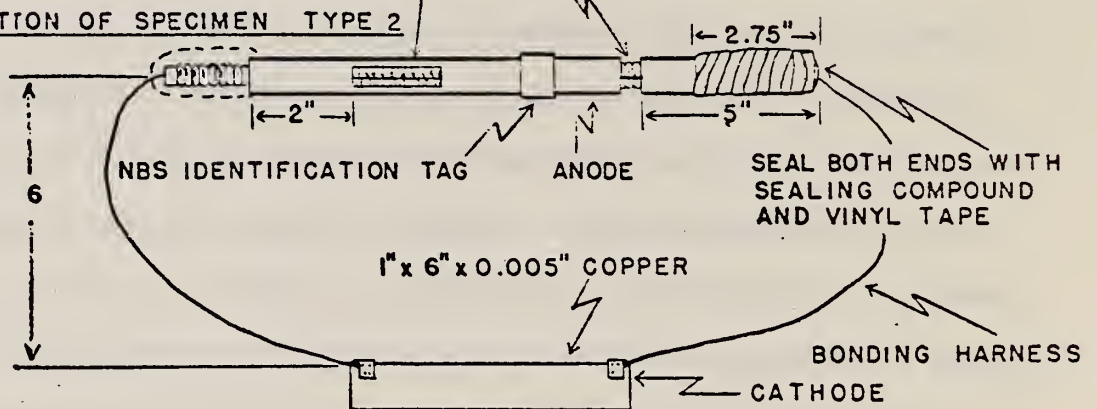
Figure 1 Preparation of specimens for cable exposure tests

PREPARATION OF SPECIMENS
FOR CABLE EXPOSURE TESTS

SPECIMEN DIMENSIONS

PREPARATION OF SPECIMEN TYPE 1

PREPARATION OF SPECIMEN TYPE 2

In order to expose the shield material to the environment and to simulate conditions which may occur in field installations of telephone cables, specimens were prepared as shown in figure 1. Specimens used in this study were polyethylene jacketed cable lengths [approximately fourteen inches (35.6 cm) long] containing metallic or plastic coated metal shields. With a few exceptions, the shield was exposed by stripping the outer polyethylene protective jacket at two areas, one each approximately four inches (10.2 cm) from either end of the cable length, creating a window and a ring. The window was an exposed area along the length of the cable approximately two inches (5 cm) long x 0.5 inch (1.3 cm) wide, while the ring was an exposed area 0.5 inch (1.3 cm) wide around the circumference of the cable. In addition, some of the systems were electrically coupled to copper strips by mechanically bonding the strip to electrical wires which were in turn mechanically bonded to the shield at the ends of the cable. Coupling the shield to copper thus created a galvanic cell between the copper and the shield material. This was done to simulate field conditions in which dissimilar metal shields may be coupled either to existing cable systems having copper shields or to copper ground rods. The ends of the specimens were sealed with a sealing compound and wrapped with vinyl tape to prevent entry of moisture at the end areas.
